Improvements of the Tungsten Guard Limiter of 4.6GHz Lower Hybrid Wave Antenna of the EAST and its Service Status under Operations

¹Institute of Plasma Physics, Chinese Academy of Sciences

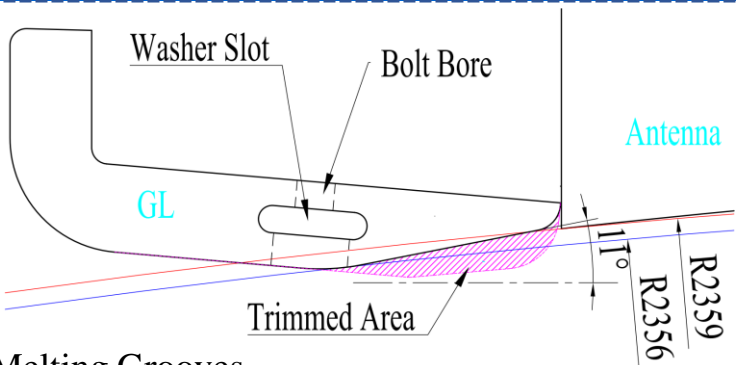
No Melting Grooves

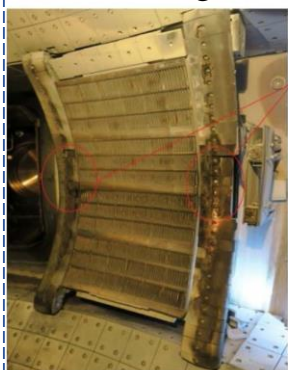
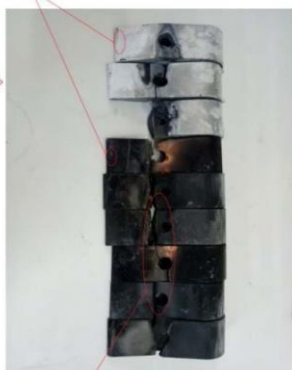
Cracks

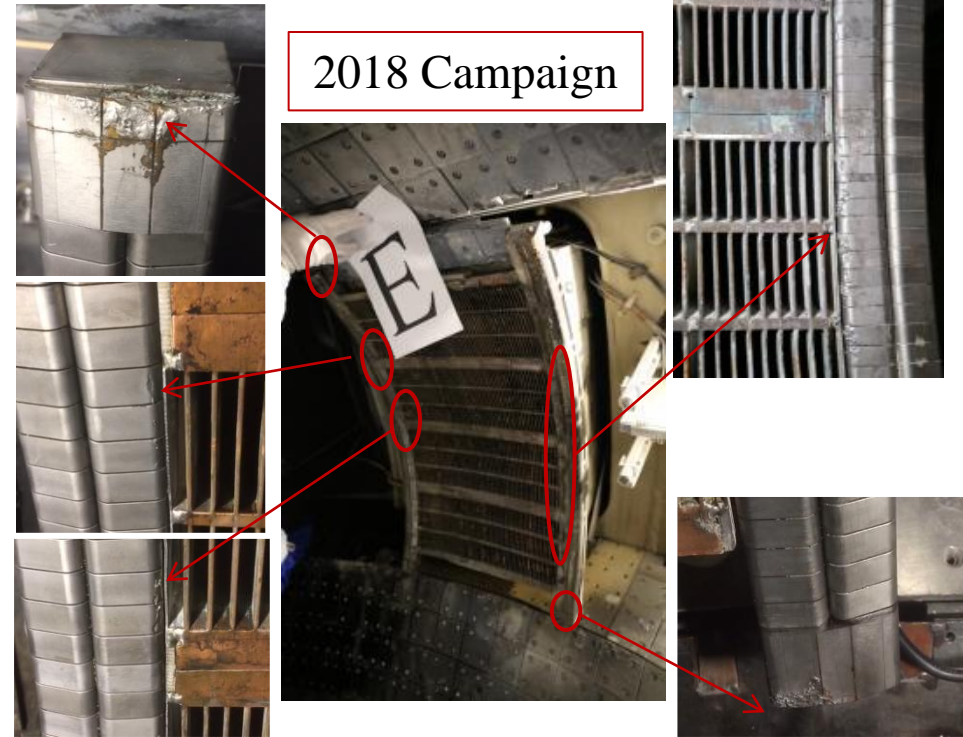
2017.11 First installation

1. Melt on the end boxes
2. Melt on the inner corners of the monoblocks

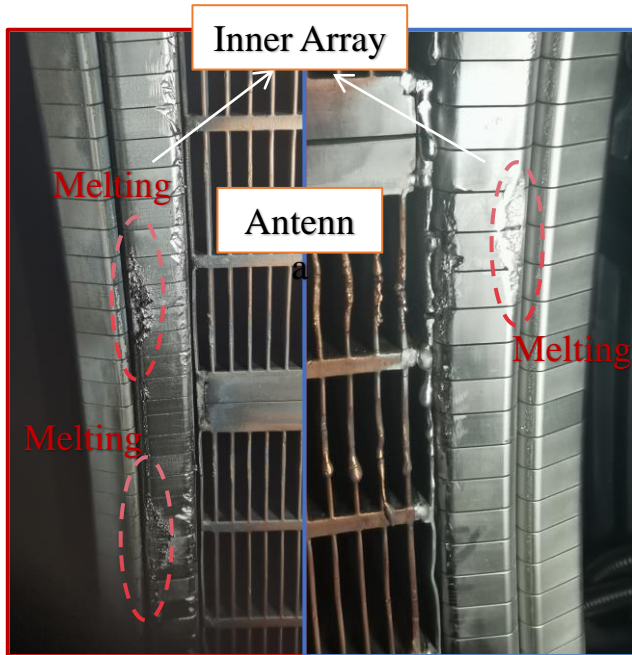
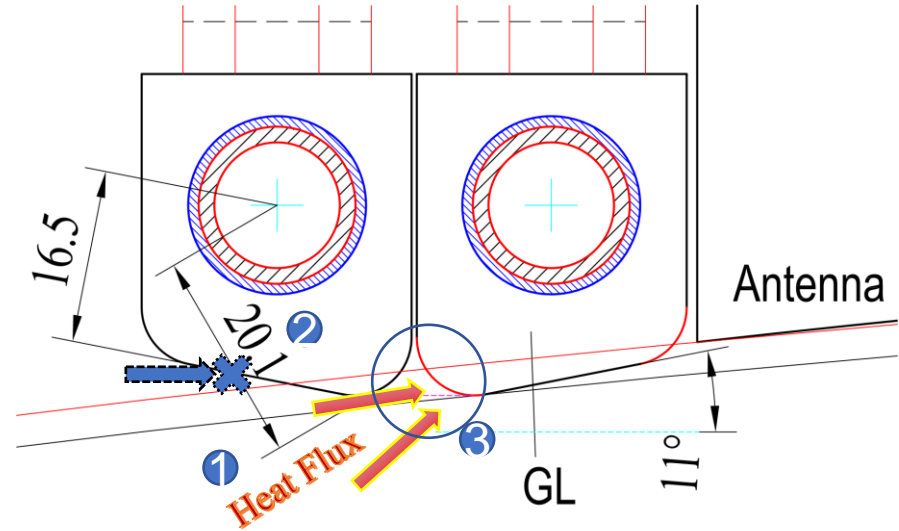
1. Melting on the top

Possible Reason:

- ① Incident heat flux on the corner
- ② Low heat exhaust ability of the top
- ③ Potential assemble misalignment

- ① Top of the GL should be on one monoblock

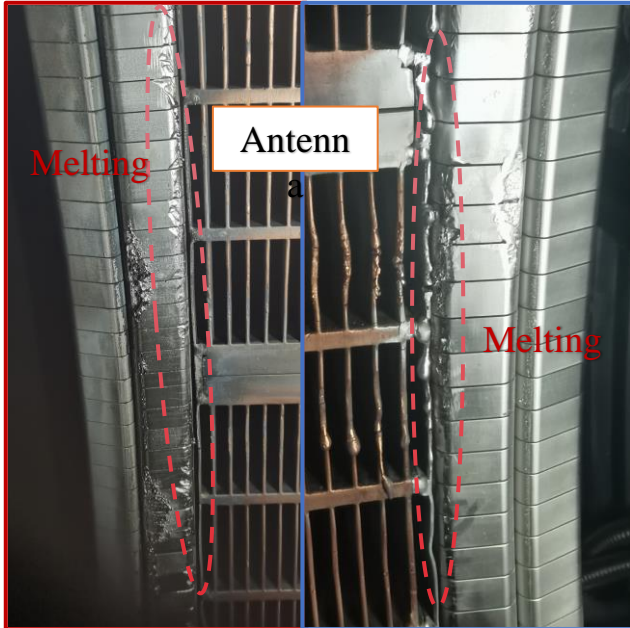
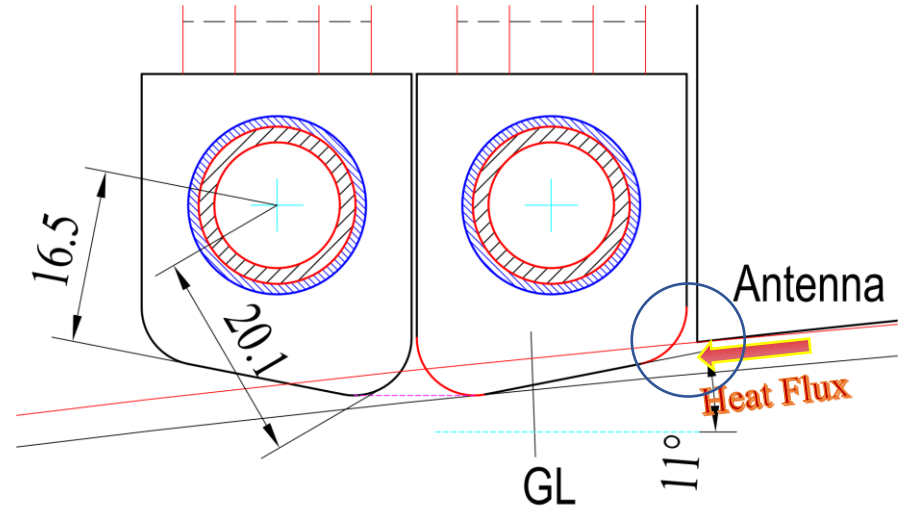
2. Melting on the Inner Fillet

Possible Reason:

- ① Incident heat flux on the Fillet
- ② Fast Electron Layer close to the grill
- ③ Potential assemble misalignment

- ① Set the inner corner below the grill(considering misalignment)

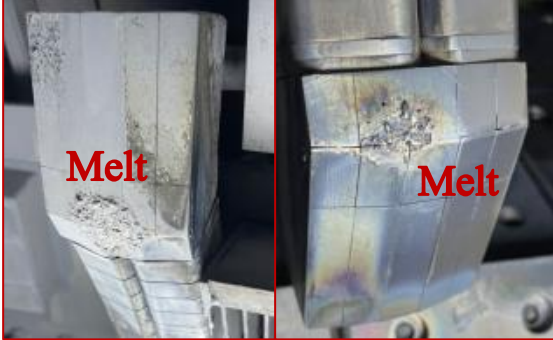
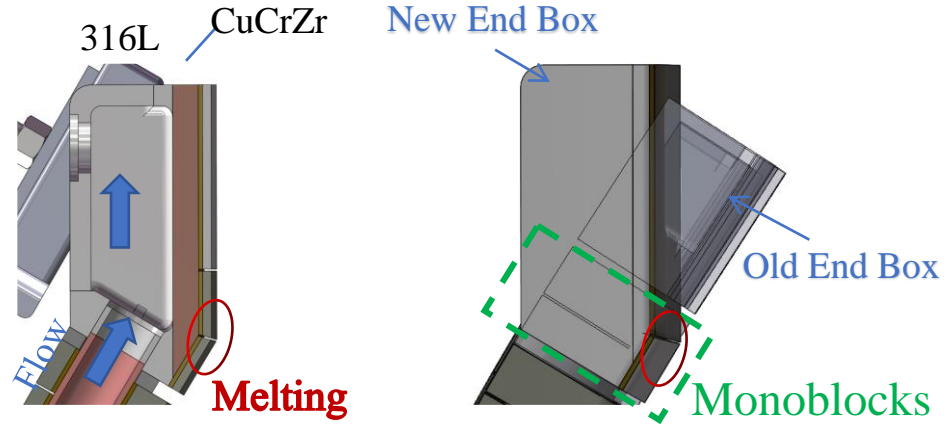
3. Melting on the End Box

Possible Reason:

- ① Poor local heat exhaust ability
- ② Closet location to the plasma

- ① Elongate the monoblock components

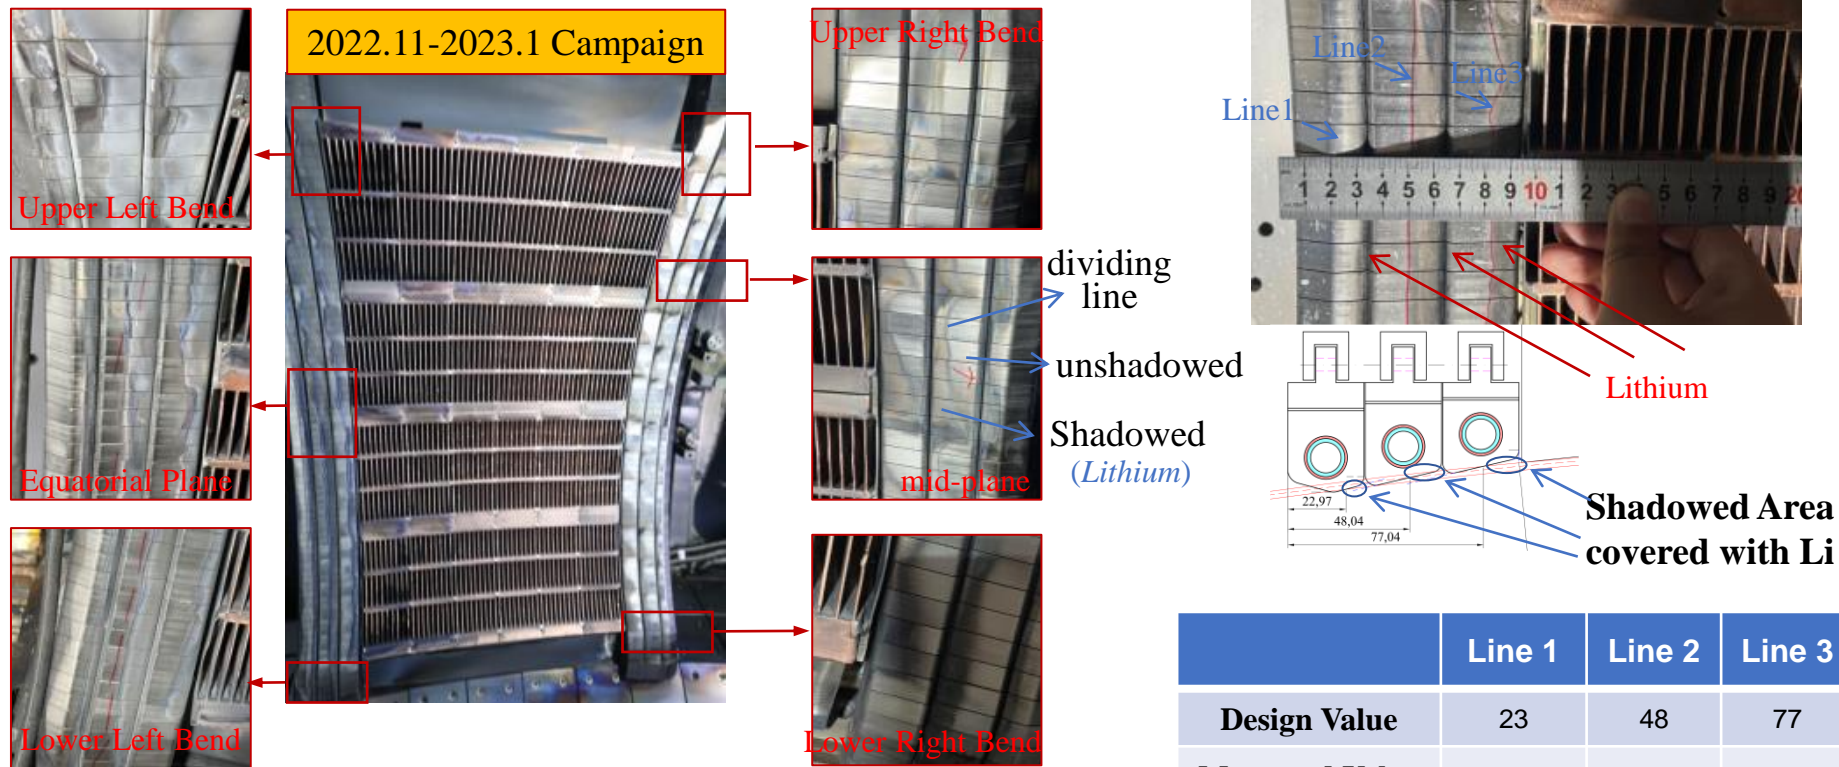
Line 1	Line 2	Line 3
Design Value	23	48	77
Measured Value	24	56	83

- No visible Damage found on the surface of the GL
- A dividing line found between the shadowed and unshadowed area

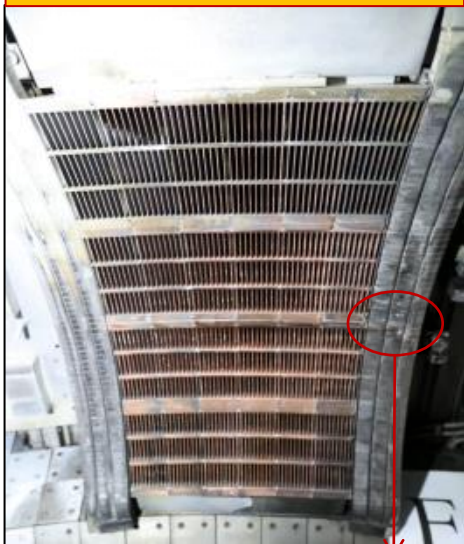
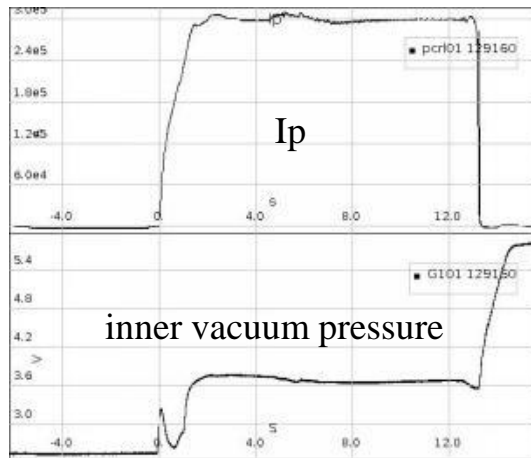
copper leakage location
