Analysis of full WEST divertor tiles after C4 campaign by TOF ERDA

I. Bogdanović Radović¹, Z. Siketić¹, G. Provatas¹, K. Ivanković¹, A. Hakola², J. Likonen², M. Diez³, E. Bernard³, E. Tsitrone³, T. Vuoriheimo⁴, M. Balden⁵ and the WEST team*

WEST C4 campaign

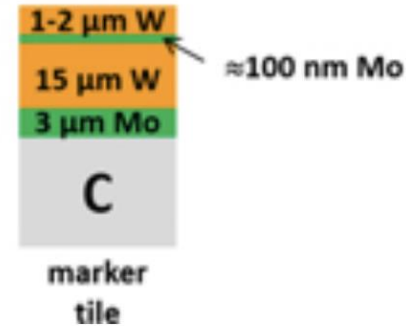
Post mortem RBS and NRA performed on erosion marker tile to assess net erosion/deposition pattern, film composition and D content

- IBA : up to $\sim 1.5 \mu\text{m}$ for light impurities (B, C, O)
- up to $\sim 3 \mu\text{m}$ for D
- Cannot fully probe thick deposited layers
- No information about He content
- No indication of W fuzz confirmed
- “Nanoholes” evidenced in post C4 deposits, but similar features also seen after C3 : cannot be attributed unambiguously to He

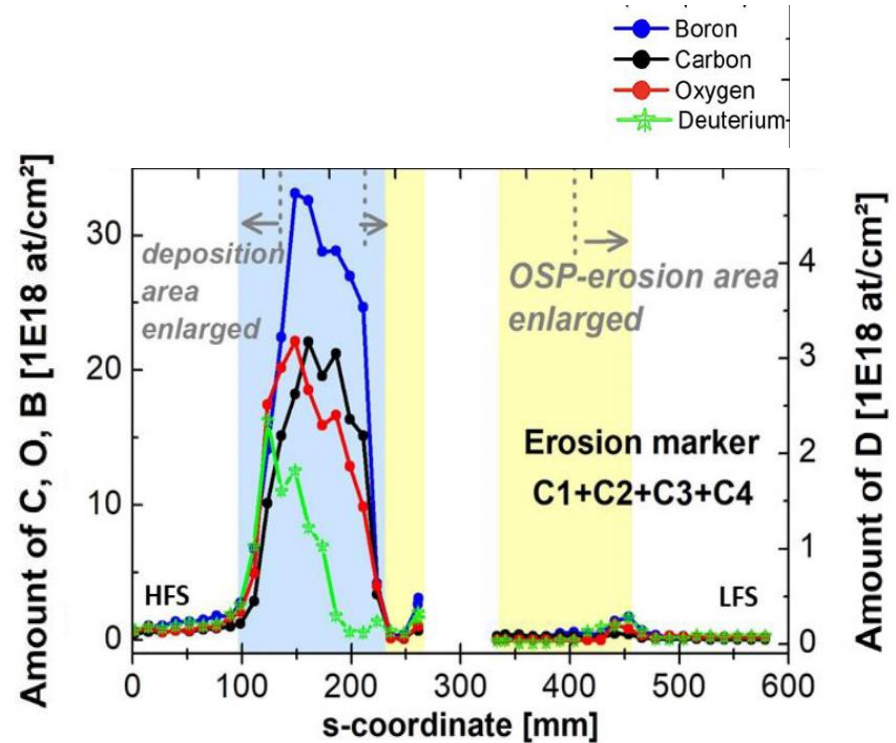
OSP erosion area enlarged, ISP erosion area shifted after C4

- Thick deposition area on the HFS also enlarged
- C, B, O significantly increased after C4 (longer plasma duration + increased number of boronisation)
- D content follows B/C profiles, but D depleted after C4 near the strike point area : impact of He plasmas?

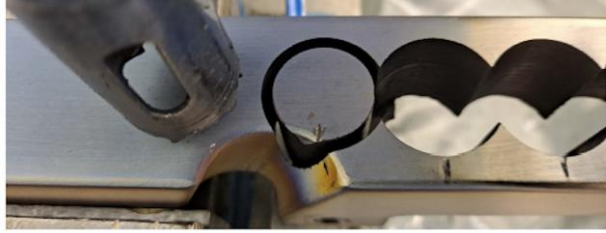
Inertial standard inner/outer tiles from **sectorQ4A** (max OSP/max ISP) cored for ToF-ERDA at the VTT, Finland

- 17 samples from inner sector – 7iA to 7iQ
- 13 samples from outer sector – 18oA to 18oM

TOF ERDA was performed along the poloidal direction, from high-field side (HFS) to low-field side (LFS).

- each sample was measured in the middle
- beam spot size $\sim 2 \times 3 \text{ mm}^2$

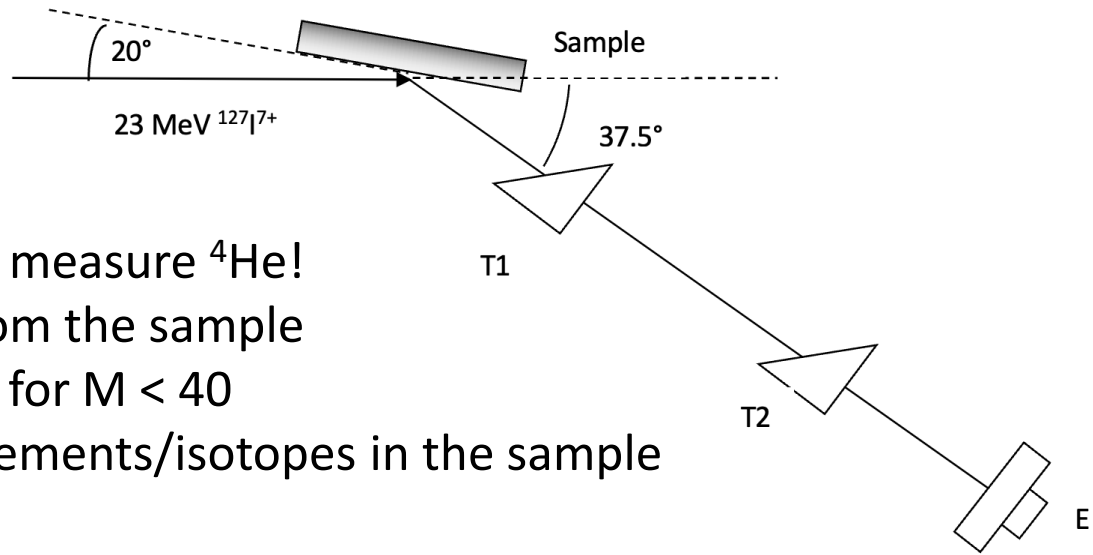
Time-Of-Flight Elastic Recoil Detection Analysis (TOF ERDA)

- The only IBA technique that can measure ^4He !
- Heavy MeV ions recoil atoms from the sample
- Mass resolution is better than 1 for $M < 40$
- Simultaneous detection of all elements/isotopes in the sample

- Surface roughness
- Difficult to distinguish neighboring mid Z elements due to recoil signal overlap

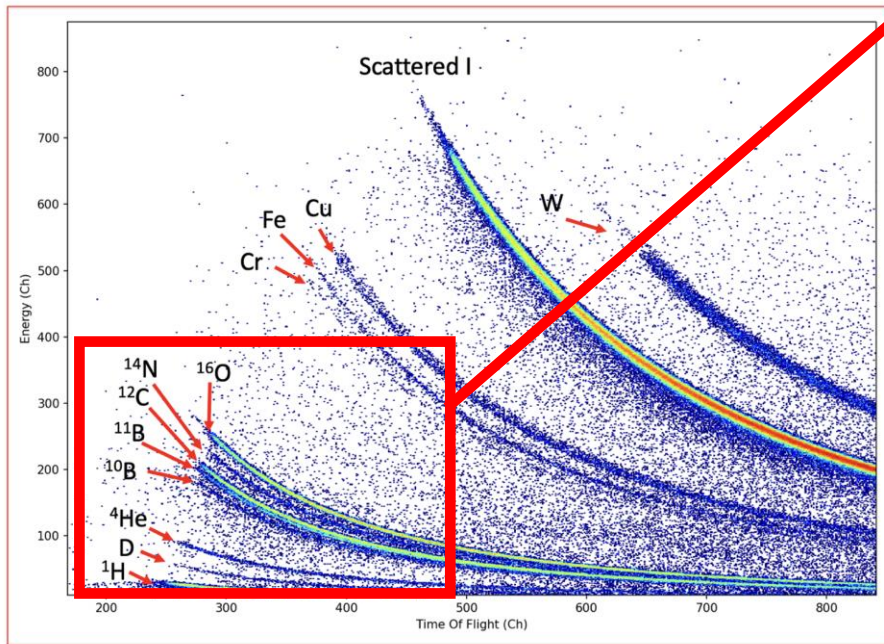
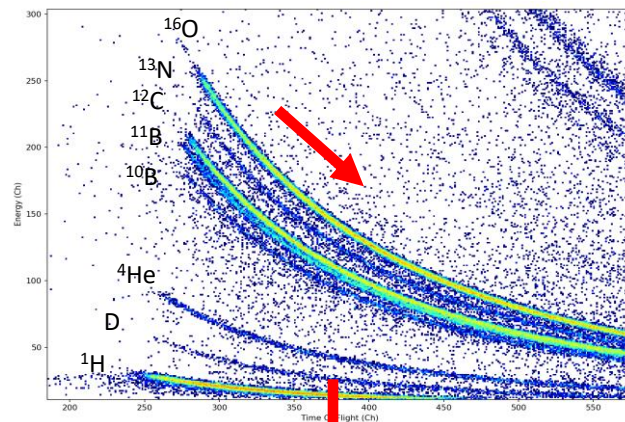
Sample Q4A-7iG – TOF ERDA spectrum

- depth profiles and at% of all elements/isotopes

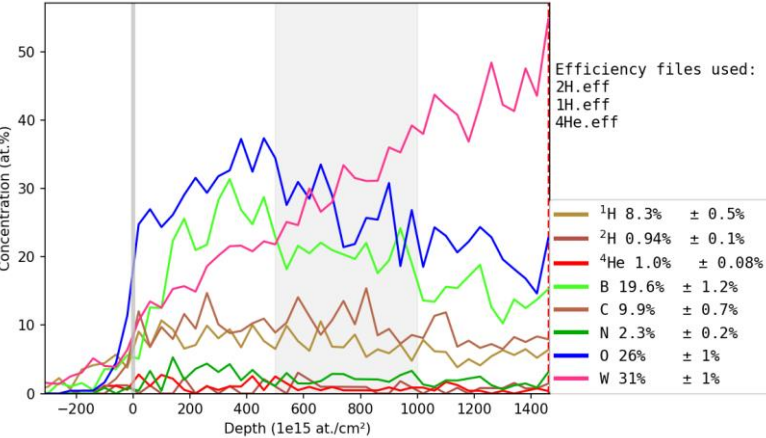
TOF ERDA depth profiles

18oF (s=433 mm)
erosion part OSP

7iF (s=104,5 mm)
thick deposit

18oH (s=470 mm)
thin deposit LFS

Distribution of elements
homogeneous in depth –
surface O peak

Very rough sample

Concentration in the near
surface region is not
homogeneous

Composition near the surface: thick deposits (B, C, O, H), erosion ISP (B, O, W, He, H), erosion OSP (W, C, He, B)

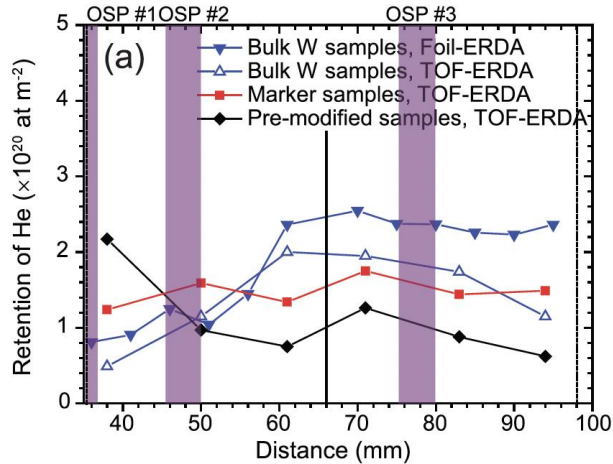
- dedicated helium campaign in 2015 in the full W ASDEX upgrade, H mode, one day

- difference in He retention – differences in exposure and in the local erosion/deposition balance due to different plasma conditions in both devices

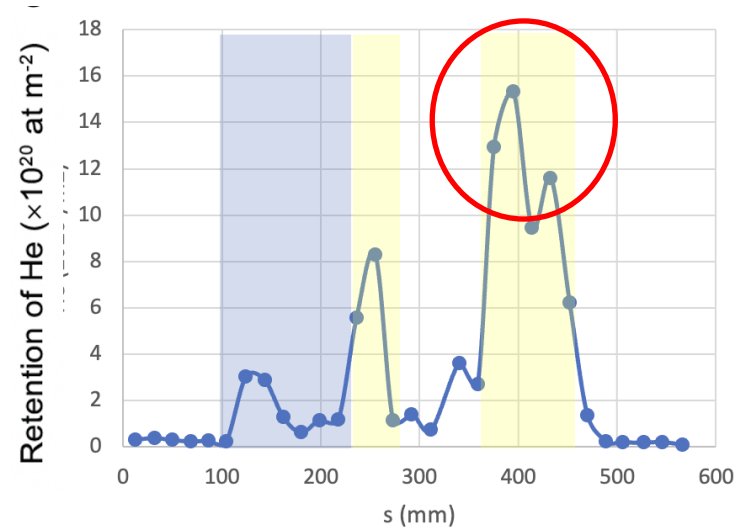
WEST C4 – L mode, more days

surface density $> 10^{21}$ He/m² at the OSP

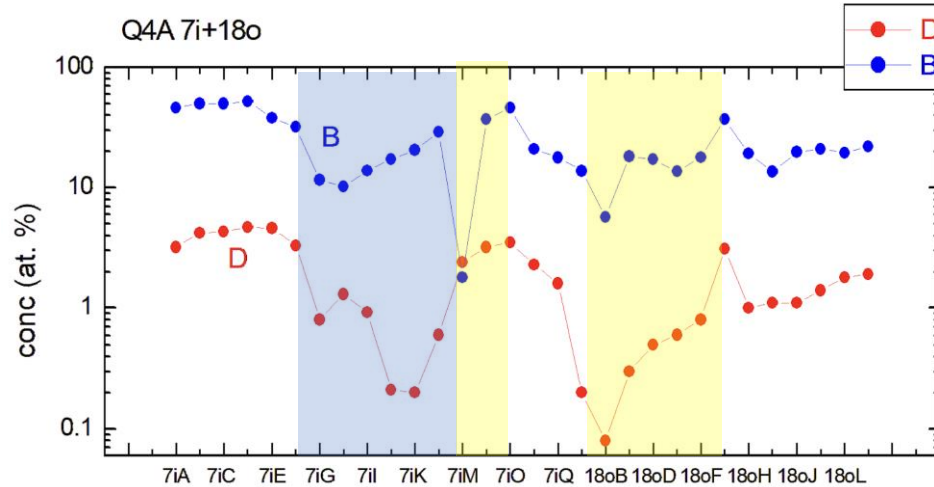
D profile vs. B profile

- D profile is following B profile in the **near surface regions** and is following less C profile (conclusion from previous NRA measurements which goes deeper)

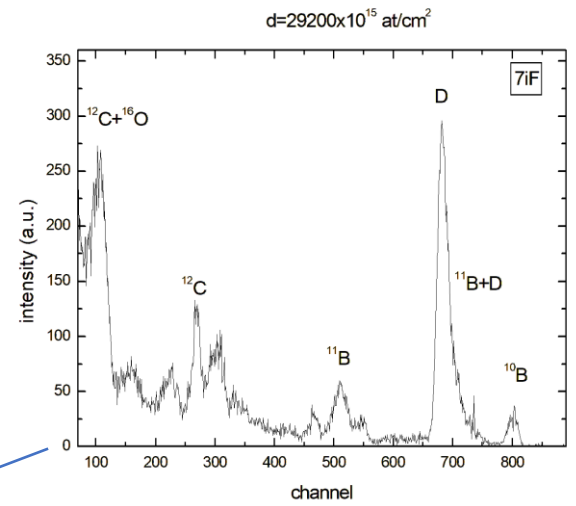
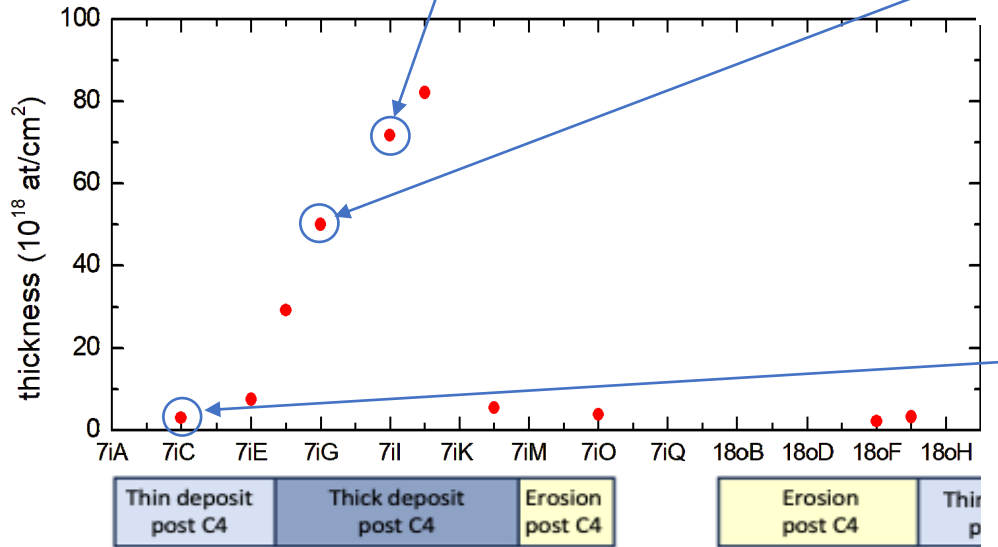
- NRA spectra of thick, thin and sample with intermediate thickness

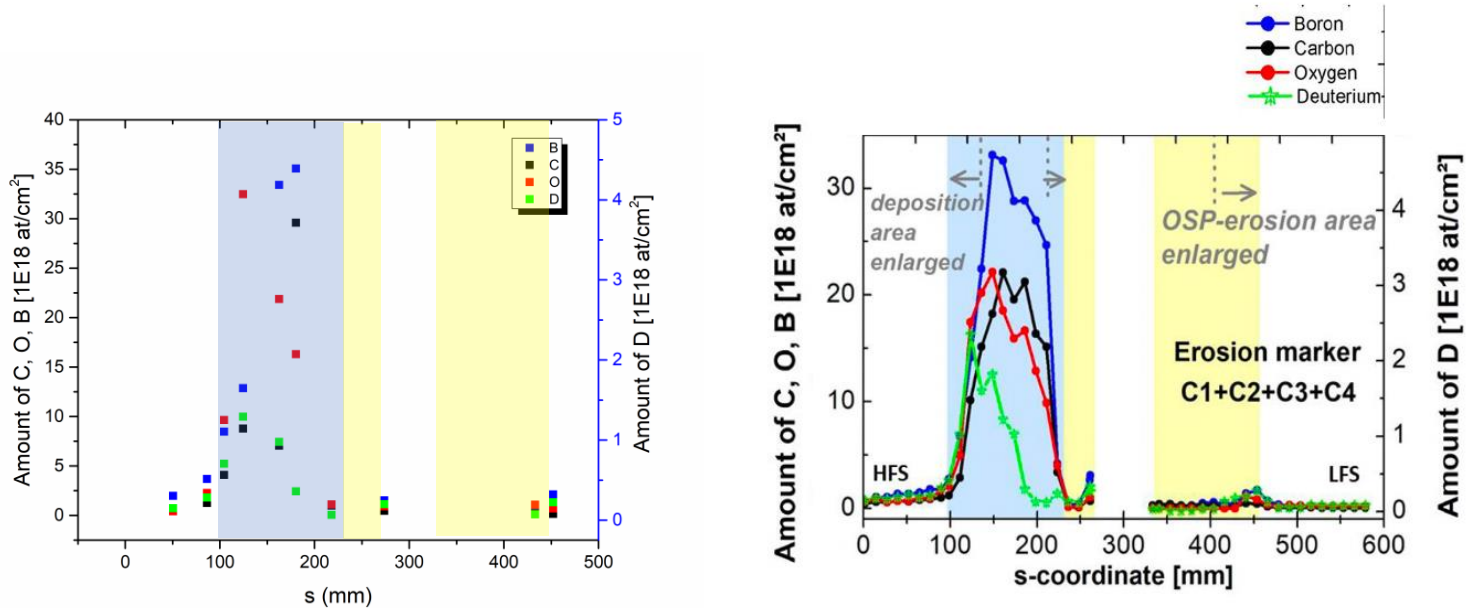
Comparison with previous NRA analysis of C4 erosion marker tiles

- D and B in good agreement, C and O in fair

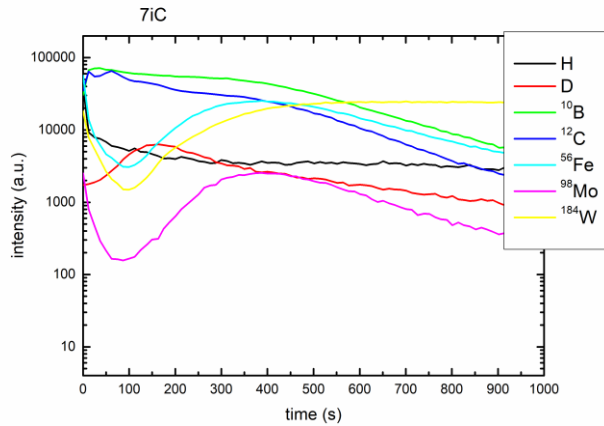
SIMS results – inner tile

Conversion to depth - 0.5 nm/s

7iC (s=50.5 mm) - thickness ~200-300 nm, dominated by B and C while D only present closer to the W interface

7iJ (s=180.5 mm) - thickness up to 5-6 microns, B and C strongly present throughout the layer; in addition metals present throughout the layer

7iN (s=255.5 mm) erosion zone – thickness ~100-200 nm and B, C and D peaks (surface peak- implantation?)
