Improvements of the Tungsten Guard Limiter of 4.6GHz Lower Hybrid Wave Antenna of the EAST and its Service Status under Operations

¹Institute of Plasma Physics, Chinese Academy of Sciences

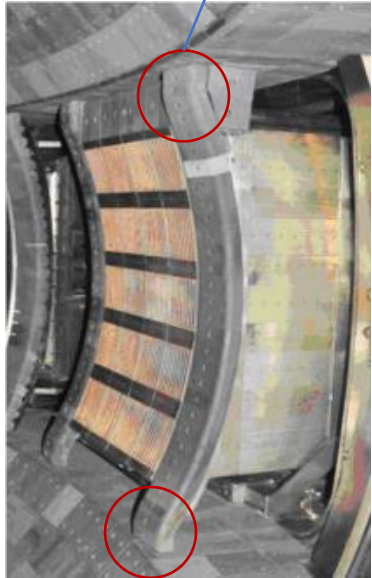
previous graphite tils GL

Bend

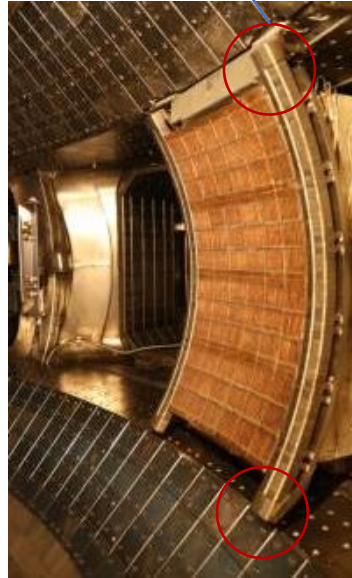
new Tungsten GL

No Bend

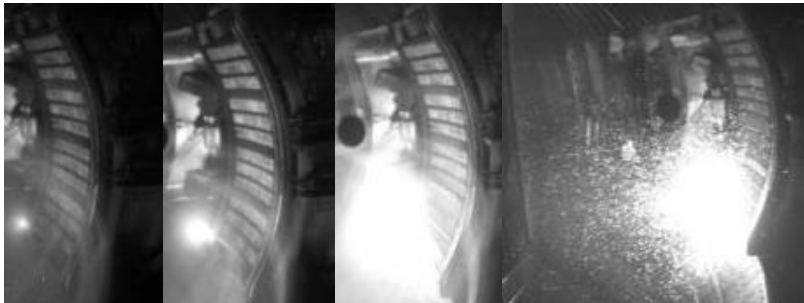
Possible Reason:

- ① Poor local heat exhaust ability
- ② Closet location to the plasma

Suggestion:

- ① Elongate the monoblock components

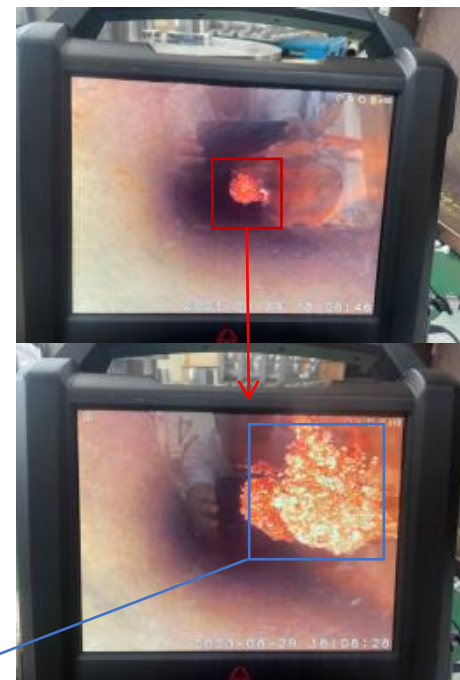
#129160

hotspot

#Shot129160 :

I_p 310KA, 13.2s, ne~4.5
LH2~2.3MW
EC~2MW
IC~2.5MW
NBI_1L~50kV
NBI_1R~55kV
NBI_2R~55kV

Lasting 3.8s

Over CHF?

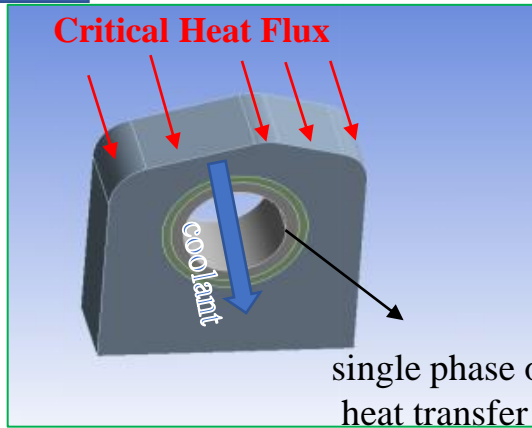
Original

coolant pressure: 0.6MPa
coolant temperature: 27°C

Flow speed (m/s)	Coolant temperature (°C)	CHF (MW/m ²)
5	27	~29.8
6	27	~32.2
7	27	~34.4
8	27	~36.5
9	27	~38.3
10	27	~40.1

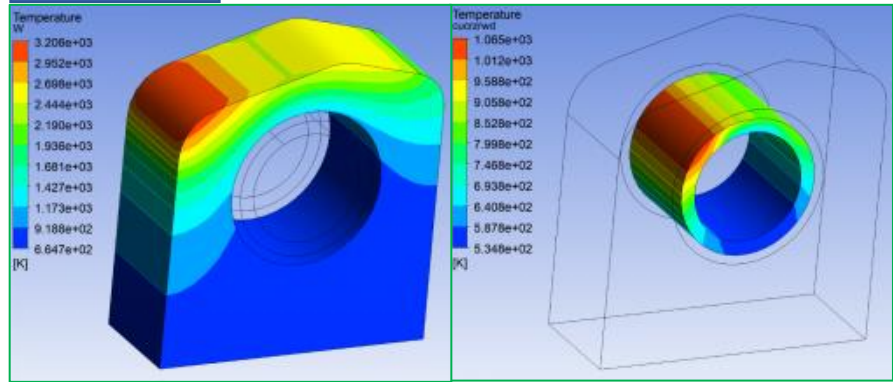
Improved

coolant pressure: 2MPa
coolant temperature: 27°C
coolant speed : 7.4m/s

CHF (MW/m ²)	
Max. allowable heat flux (MW/m ²)	41
Max. temperature (Wu) /°C	2933
Max. temperature (CuCrZr Pipe) /°C	954
melting point (CuCrZr) /°C	1080

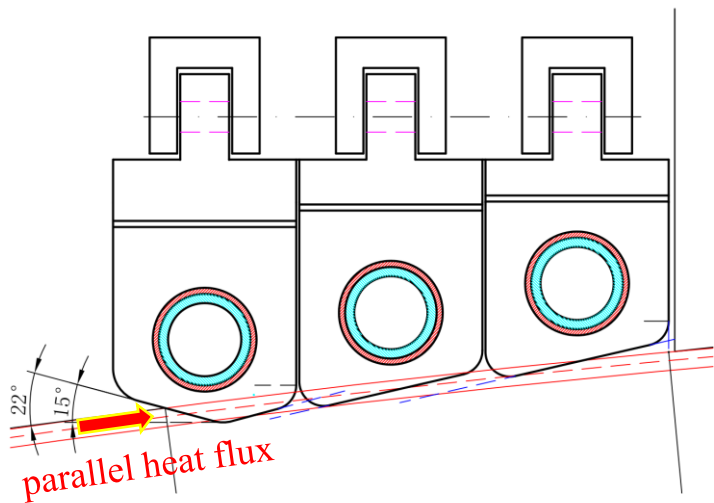
Original

PHF(parallel heat flux)

$$\text{CHF} \geq 34.4 \text{ MW/m}^2$$

$$\text{CHF} = \text{PHF} * \sin 22^\circ$$

➡ $\text{PHF} = 91.7 \text{ MW/m}^2$
